Manhole Inspection Summary

Manhole # S43C2_032MH

Insp Date: **12/20/07 12:50 PM**

Location Address: **1117 Inner Cir**

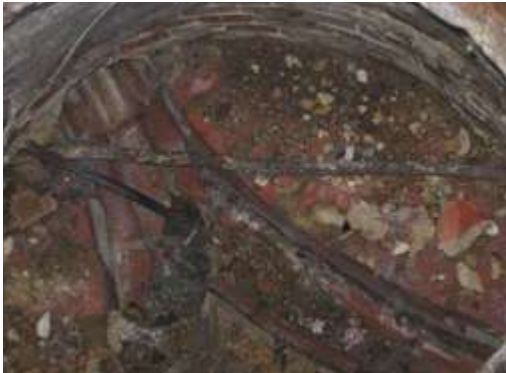
Defect 2

Poles

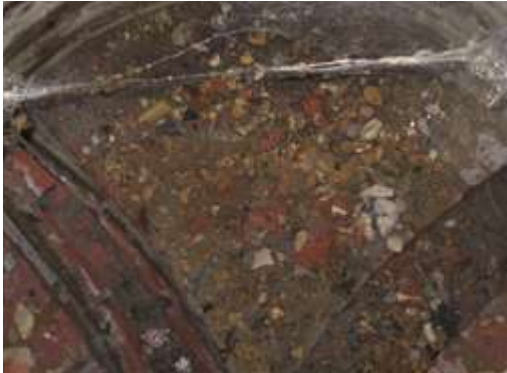
Defect 1

Condition: ☐ Sound ☐ Cracked ☐ Root Intrusion ☐ Deteriorated ☐ Leaks ☒ **Debris**

Debris

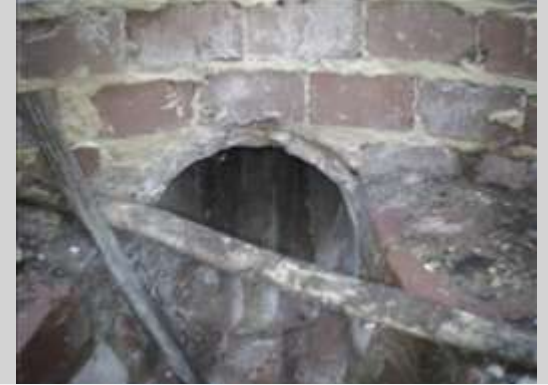
12 O'Clock Outflow

8 in. Circular Gravity Sewer
Pipe Out @ 12 O'Clock

Pipe Height: **9.6** (in.) Rod and Bar (Angled)

Pipe Material: **Clay** ☐ Pipe Lined

Invert Depth: **6.77** (ft.) Flow Characteristics: **None**

Infiltration: **None** Pipe Seal Cond: **Sound**

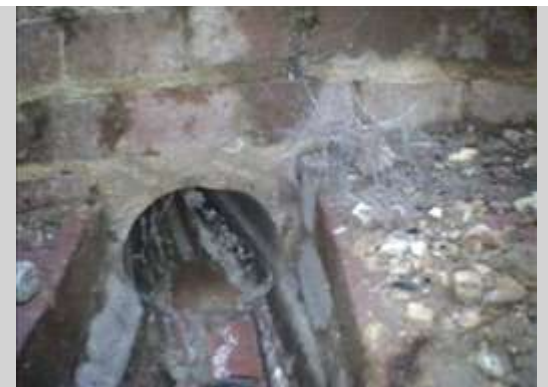
4 O'Clock Inflow

6 in. Circular Service Sewer
Pipe In @ 4 O'Clock

Pipe Height: **6** (in.) Rod and Bar (Angled)

Pipe Material: **Clay** ☐ Pipe Lined

Invert Depth: **6.42** (ft.) Flow Characteristics: **None**

Infiltration: **None** Pipe Seal Cond: **Sound**

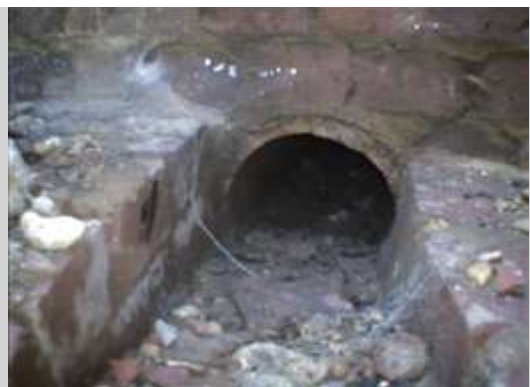
8 O'Clock Inflow

6 in. Circular Service Sewer
Pipe In @ 8 O'Clock

Pipe Height: **6** (in.) Rod and Bar (Angled)

Pipe Material: **Clay** ☐ Pipe Lined

Invert Depth: **6.35** (ft.) Flow Characteristics: **None**

Connects To: **Stub connection / abandoned**
